XXVI CONGRESO INTERNACIONAL DE
MANTENIMIENTO Y GESTIÓN DE ACTIVOS

Reducción de fallas y costos de activos con Prometheus APM

Karen Sofia Gutierrez – Consultor Funcional,
24 de Abril del 2024

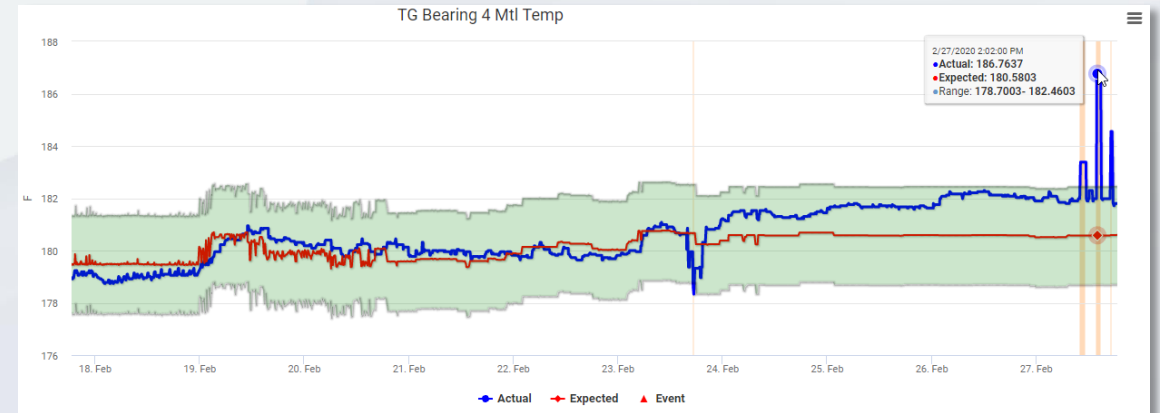
Cojinete de turbina

- **Detectar** - La temperatura del metal del cojinete de turbina de potencia # 4 aumentó de 180 °F históricamente estable a 186 °F. Los datos de alta frecuencia revelaron picos de 1 minuto a > 2,000 grados F.

- **Diagnosticar** - Las tendencias de diagnóstico incorporadas mostraron que 1) todas las demás temperaturas del metal del rodamiento se mantuvieron estables, 2) todas las vibraciones del rodamiento se mantuvieron estables sin cambios, 3) la carga en el equipo no fue anormal y 4) las muestras de aceite lubricante fueron cuestionables.

- **Resolver** - Las operaciones aprovecharon la oportunidad de la interrupción existente el próximo fin de semana para abrir la tapa del rodamiento e inspeccionar localmente. Se determinó que un sistema de aceite de control tenía una fuga en el aceite lubricante, lo que provocaba barniz en el rodamiento # 4, lo que provocaba un aumento de la temperatura del rodamiento.

- **La planta cuantificó la evitación de costos en > \$ 2,000,000 debido a lo que habría sido una futura interrupción forzada evitada!**

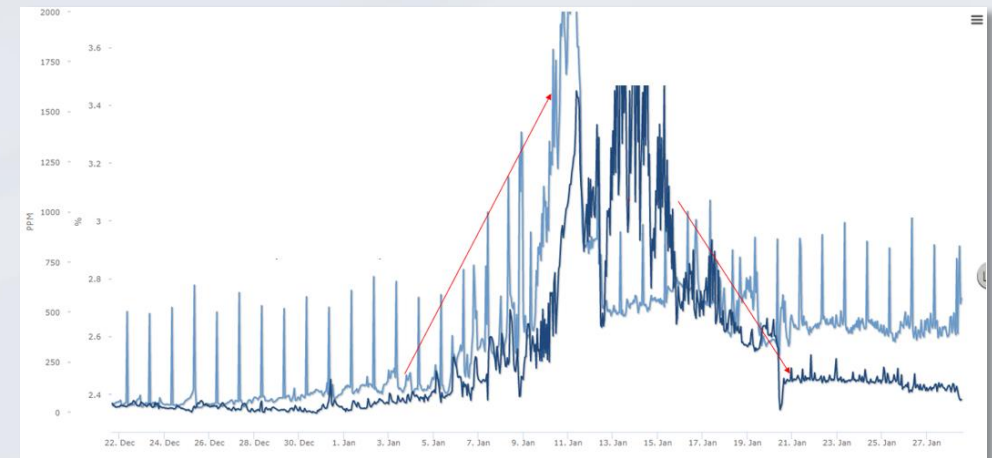
Riesgo de explosión química

- **Detección de alertas de modelo** - Se detectó un aumento en el porcentaje de arrastre de hidrógeno
- **Diagnosticar** - La inspección local confirmó lo que inicialmente se pensó como un problema de instrumentos
- **Resolver**
 - Ops inspeccionó visualmente el flujo de CO₂ y notó que se producía un exceso de espuma (que ocurre con el exceso de arrastre de H₂), lo que indica un problema real
 - CO₂ + H₂ + Oxígeno (Espuma): conducen a un entorno explosivo peligroso. Prevención de explosiones mediante la aplicación de agente antiespumante.

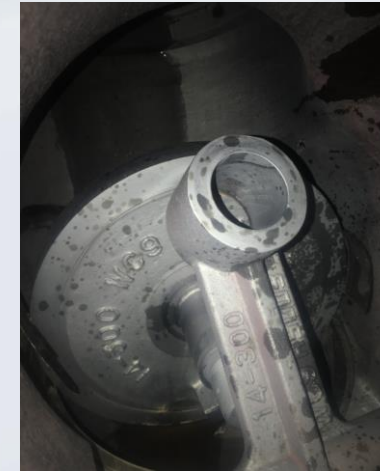
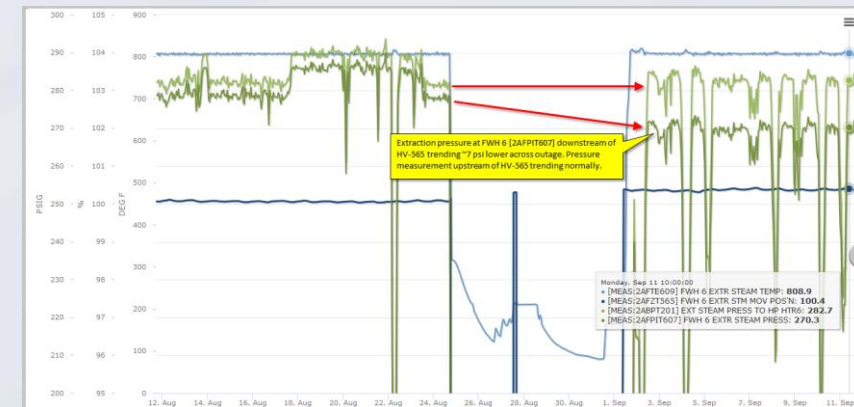
Válvula de línea de extracción

- **Detectar** - A través de una interrupción breve, la presión de vapor de la línea de extracción cayó 7 psi (de 285 psi a 278 psi.)
- **Diagnosticar** - La tendencia contextual guiada por el usuario determinada por el instrumento de presión de extracción aguas arriba no cambió, pero la posición de la válvula indicó cerrada. El P&ID complementario ayudó a identificar dónde podría estar el problema para que las operaciones se resuelvan.
- **Resolver** – Plant Ops descubrió que la tuerca del vástago del disco de la válvula se había desprendido del vástago de la válvula y encontró el disco de la válvula dentro de la línea de extracción. La lógica de control del procedimiento de apagado podría haber causado un evento de exceso de velocidad de la turbina y daños catastróficos a la turbina. Riesgo de **1,2 millones de dólares**.
